## **Summary of EPA Surface Water Sampling Results to Date**

### **Gold King Mine Blowout**

Updated August 7, 2015

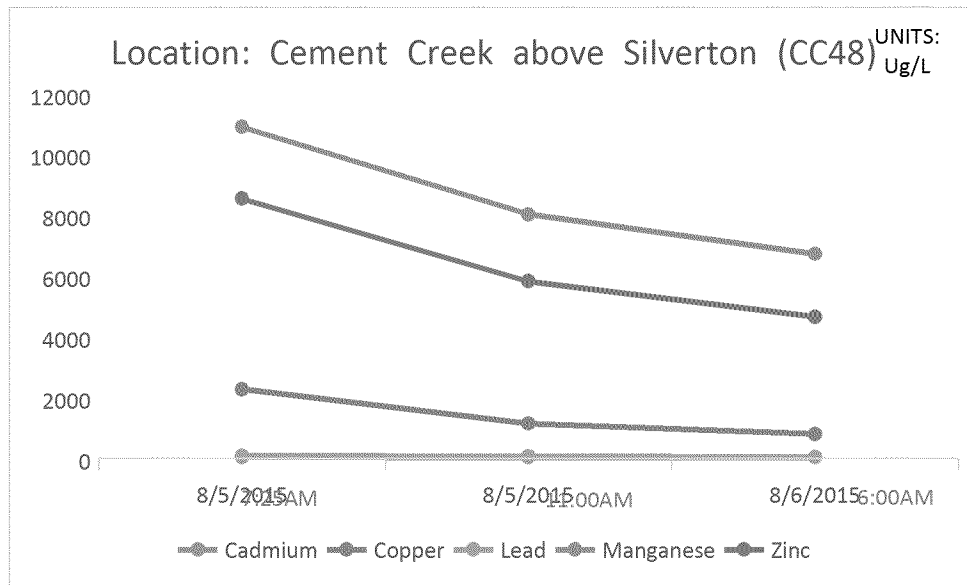
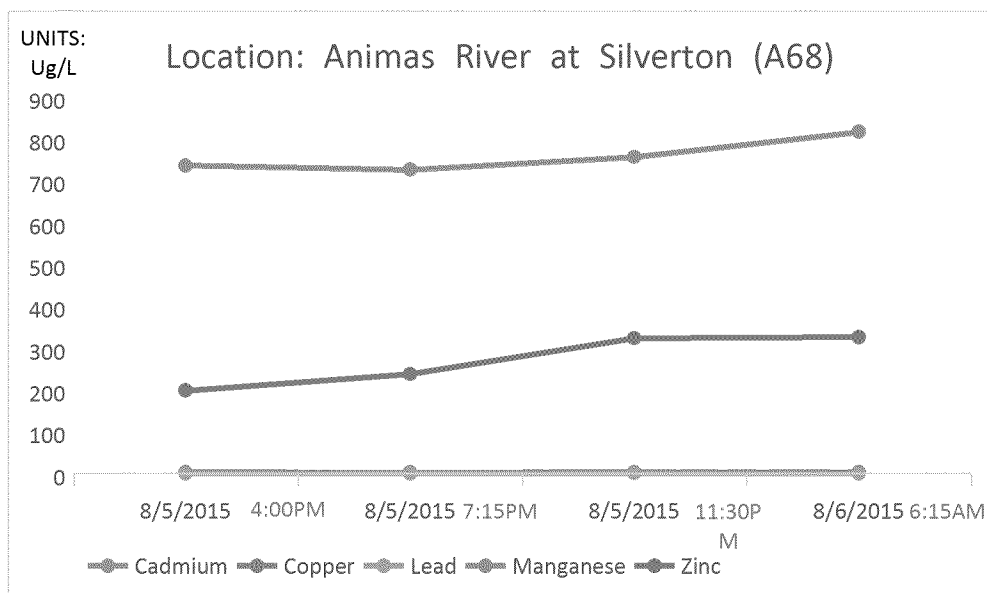
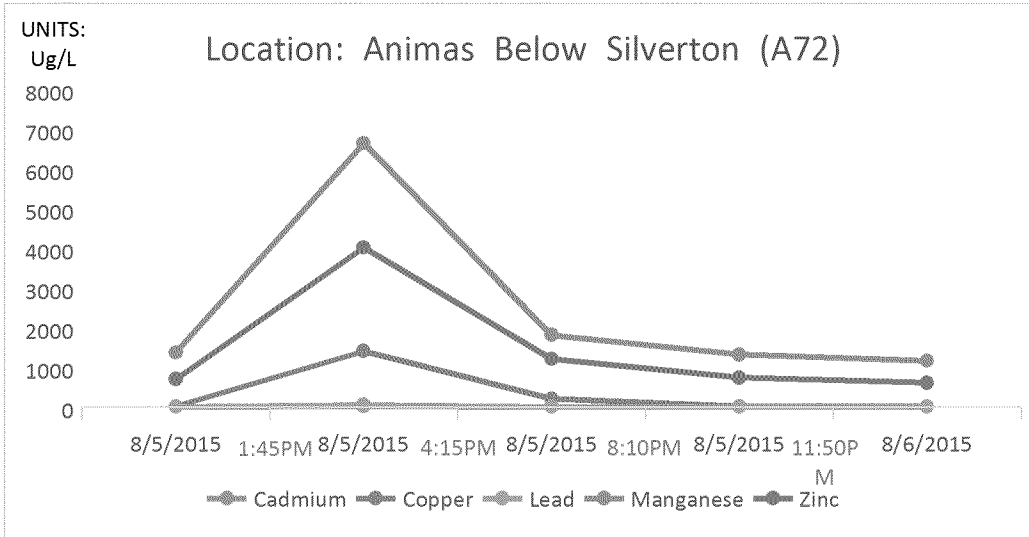
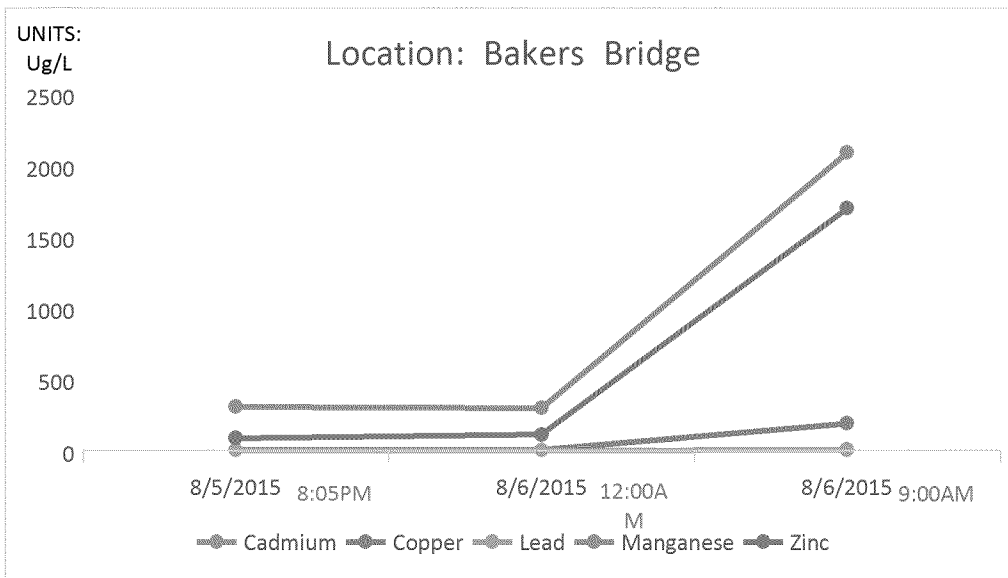
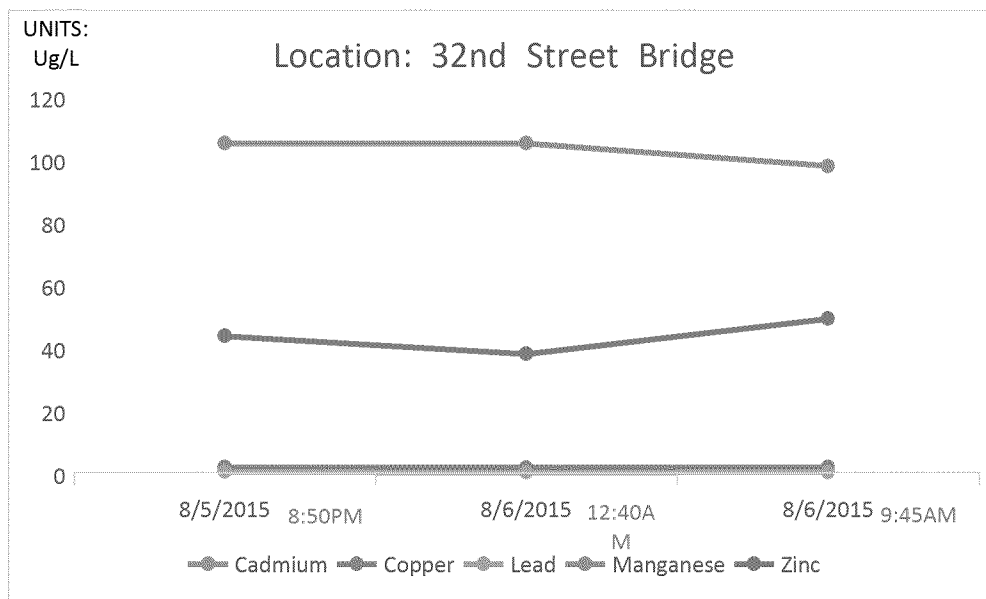
## Attachment 2: Trends

The samples were analyzed for dissolved phase metals. Cadmium, copper, lead, manganese and zinc were selected for summary in this report because historical data from the Gold King Mine indicates that these metals are good indicators of potential impacts to ecological and human health at this site. The data shows that concentrations of metals increased as the plume moved downstream and that these concentrations decreased towards baseline conditions.

EPA will continue to collect monitoring data and expects subsequent sampling events to show decreasing concentrations of contaminants as the tailing edge of the plume moves downstream.
